MACHINE SERVICE BULLETIN #112

SUBJECT: Lock for Clear-out Mechanism "C" and "E" Models

DATE: March 6, 1931

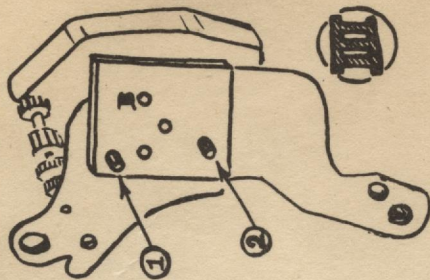
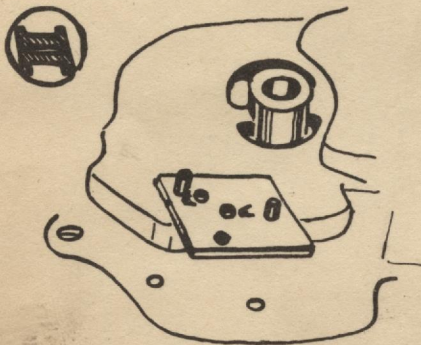
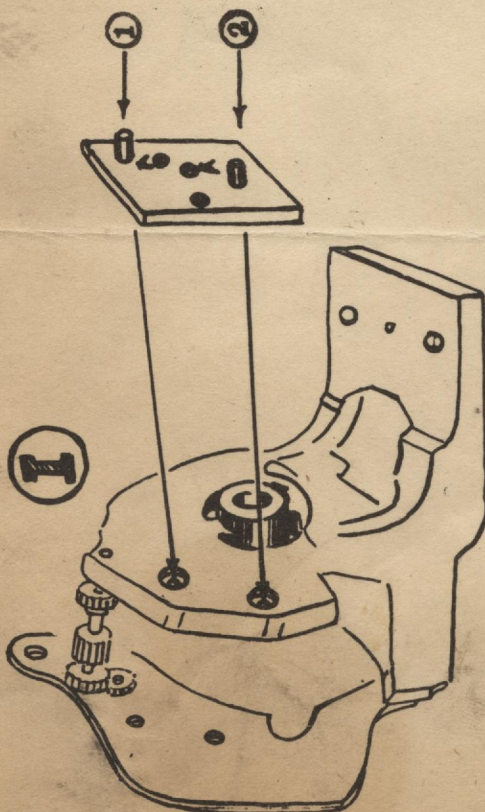
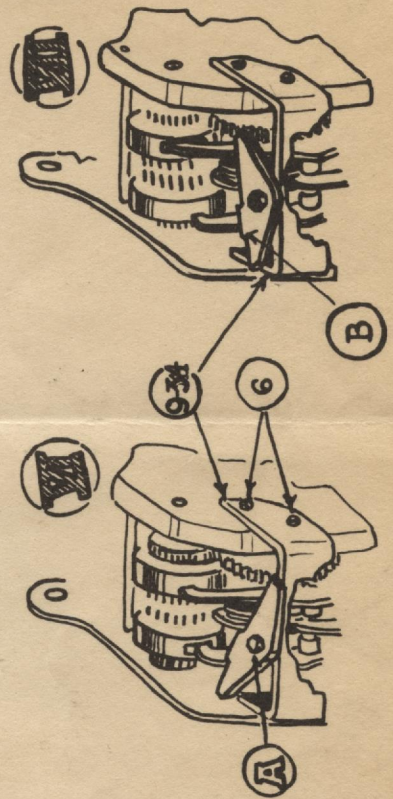
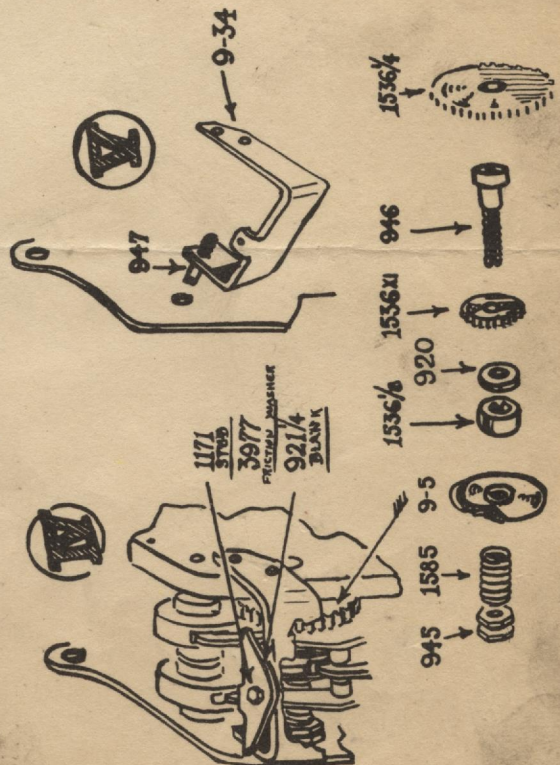
Machine Service Bulletin No. 112

Place the drill jig on the motor bracket with the side of the jig marked A, out. Pins 1 and 2 of the jig should be located in the holes in the motor bracket as shown in figure 1 of the attached sketch. Drill holes A, through the motor bracket with a #32 drill. If the drill starts to chatter after the holes are started, remove the jig and complete the drilling without the jig, and thread these holes with a #6-40 tap.

Replace parts C, D, E and F, plate 18, in their original position. In place of the original parts that were assembled on the lower 1552 shaft, parts shown in figure 4, are to be used. These are to be assembled as follows: First, the gear, 1536x1, goes over the left end of the 946 shaft with the smooth side of the gear away from the shoulder of the 946. Next, the fibre washer, 920, is assembled; then the collar, 1536-1/8, with the smooth side next to the fibre washer; then the clutch drum G, plate 18, which was removed from the bracket; then the spring, 1585, and the two lock nuts, 945. Assemble gear 1536 $\frac{1}{4}$ on the right end

Screw the 947 screw into the tapped hole in the left-hand end of the lock assembly, 9-34. This screw goes into the hole which was drilled in the 1520 plate. The bracket is fastened to the casting, with two #6 screws, into the holes that were drilled and tapped. (See figure 6). If a variation in the casting should cause a clearance between the casting and the assembly, 9-34, when the left end of the 9-34 is up against the 1520 plate, it will be necessary to pack thin washers between the 9-34 and the casting to take up this space before tightening screws #6. This is necessary to prevent the 9-34 from being sprung. However, if the variation is the other way, so that when the 9-34 is screwed tight against the casting, and the left-hand end is not tight against the plate, this can be taken care of by adjusting the eccentric stud, 1171, as 947 is long enough to act as a dowel.
